## **HUMAN FACTORS EVALUATION OF THE SINCGARS ICOM RADIO**

Richard L. Palmer

U.S. Army Research Institute  
Fort Hood Field Unit

April 1987

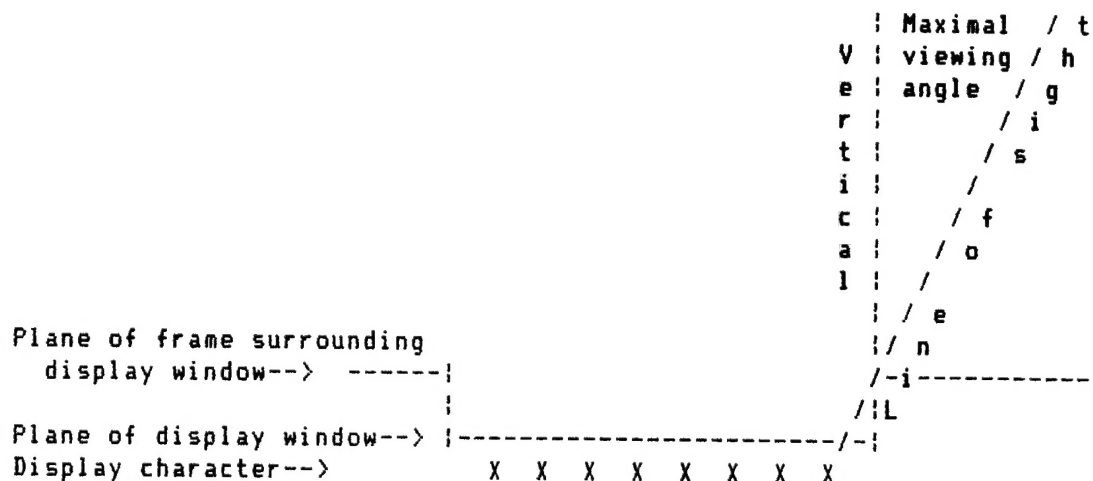
2.01 **OBSERVATION:** The maximal viewing angles for the ICOM display were measured by taking the angle between a vertical line from the plane of the display frame at the edge of the display window and a line of sight in the horizontal plane slanting away from the vertical line to the point where the edges of the characters began to be occluded from view, as in the following illustration for viewing the display from the right side:

The maximal viewing angles determined by this method were the following (they are approximate):

- 30 degrees from the top of the display
- 27 " bottom "
- 30 " right "
- 30 " left "

**IMPACT:** The nominal maximal viewing angles are improved over the non-ICOM radio (for which they were approximately 12 degrees above and below, 20 degrees to the left, and 25 degrees to the right). The improvement is, however, much greater than the nominal values would indicate because of the change from a five-character, seven-segment LED to an eight-character (seven used), 5 x 7 dot matrix LED. The dot matrix allows much greater detail in the display characters, thus making them considerably more distinct from one another even if the entire character is not visible because of extreme viewing angle. Furthermore, the first and eighth characters of the display (which graphically indicate signal strength and low battery condition, respectively) are not used for alphabetical or numerical messages, and the seventh character is not used at all; therefore the effective readability of the display (for alphanumeric prompts and feedback) from extreme side-viewing angles is greater than that indicated by the nominal values given. When the first, seventh, and eighth characters are not considered, the effective angles for viewing from the left and right are approximately 62 and 82

degrees, respectively. Thus, while the top and bottom angles are still somewhat restricting, the side angles are not.

**COMMENTS/POSSIBLE IMPROVEMENTS:** The fact that the display characters are considerably inset from the surface of the display limits the maximal viewing angles. Design efforts should attempt to minimize this inset. The bottom viewing angle (27 degrees) could possibly be widened by tapering the top edge of the frame around the keypad. (Of course, nighttime security considerations tend to work in opposition to viewing considerations, and in some situations there may be reasons to minimize rather than maximize viewing angles.)
